# EXHIBIT 1

DECLARATION OF DAVID SOUTHWELL

7. In 2003, the National Highway Transportation Safety Administration commissioned a study to determine how to improve the outdated FMVSS standards relating to tires. This study was published in a paper titled "Tire Aging Testing Development." The NHTSA study concluded that FMVSS testing does not adequately address the issue of late-life failures, such as occurred in this case. This study is attached to my declaration as "Exhibit A."

Phase 1 of the NHTSA Tire Aging Test Development Project consisted of the analysis of six different tire models collected from privately owned vehicles in the Phoenix, Arizona USA metropolitan area during the spring of 2003. This study was conducted to provide a better understanding of service-related tire degradation and to serve as the “real-world” baseline for the development of laboratory-based accelerated service life test for tires (often referred to as a “tire aging test”). On-road tires and full-size spare tires, as well as the corresponding vehicle information were collected through 22 Phoenix-area retailers in exchange for new tires at no charge to the study’s participants. Within the six differen

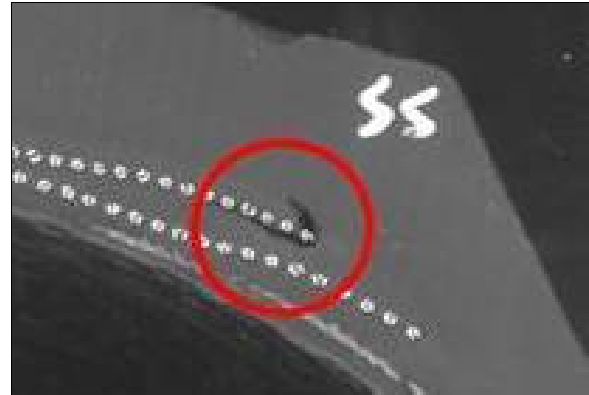
**Optical Microscopy** - To conduct optical microscopy inspections, tires were cut into cross-sections at random locations, buffed, and examined under a microscope that utilized a high precision scale for measurement of distance. Over 50 quantitative or qualitative measures were recorded for each tire cross-section. An example of an internal crack measured using optical microscopy can be seen in Figure 9. Internal cracks, especially in the critical belt edge region are thought to have a negative impact on tire durability.

**Figure 9. Example of Crack Observed in the Tire Shoulder at the Top (“#2”) Belt Edge via Microscopy**

Internal cracks in the tires were generally observed at the edge of the top (#2) steel belt, and progressing around the #2 belt edge inward between the two steel belts. The largest internal crack observed in the Phoenix tire cross-sections was 17.15 mm (0.675 in) in length. (The crack length data represent the largest cracks observed in the random section of the tire removed for microscopy only, not the largest crack in the whole tire.) The largest crack length measured per tire cross-section versus the age of the tire is displayed in Figure 10. For the six tire models studied, the largest crack length in the cross-section tended to increase with increasing tire age.
